REPORT OF COMPLIANCE SAMPLING INSPECTION
OF THE
ROCKAWAY BEACH WASTEWATER TREATMENT FACILITY
IN
ROCKAWAY BEACH, MISSOURI

NPDES PERMIT NUMBER: MO-0108162

SEPTEMBER 10-13, 2007

U.S. ENVIRONMENTAL PROTECTION AGENCY
Region VII
Environmental Services Division

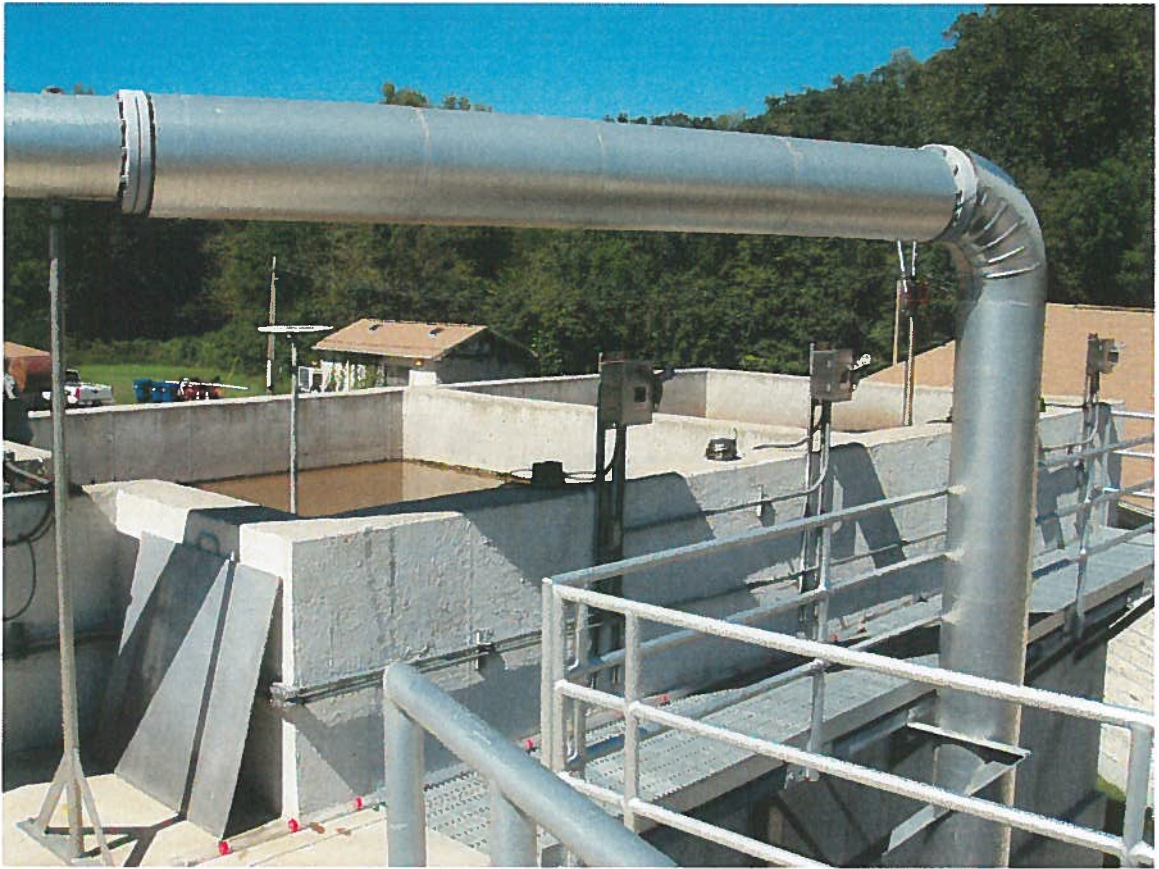
Photo no. 1 This photo was taken looking northwest from the influent headworks located between the two aeration tanks. The photo shows the anoxic basins. The building in the upper left of the photo is the laboratory/office. The silver pipe at the top of the photo carries material from the mechanical bar screen to a container on the ground.

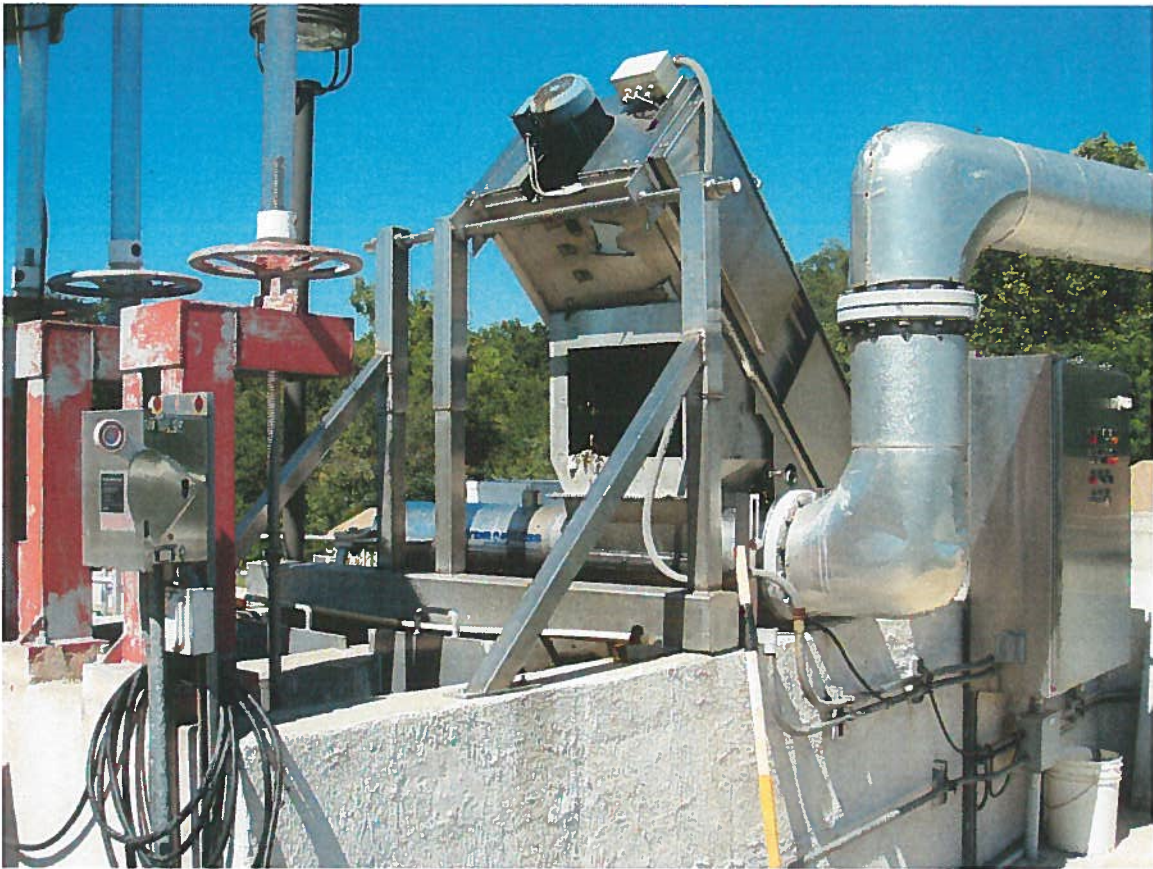
Photo no. 2 This photo was taken looking northwest from the influent headworks located between the two aeration tanks. The photo shows the upper end of the mechanical bar screen. The pipe to carry the screenings to a container on the ground is located at the right of the unit.

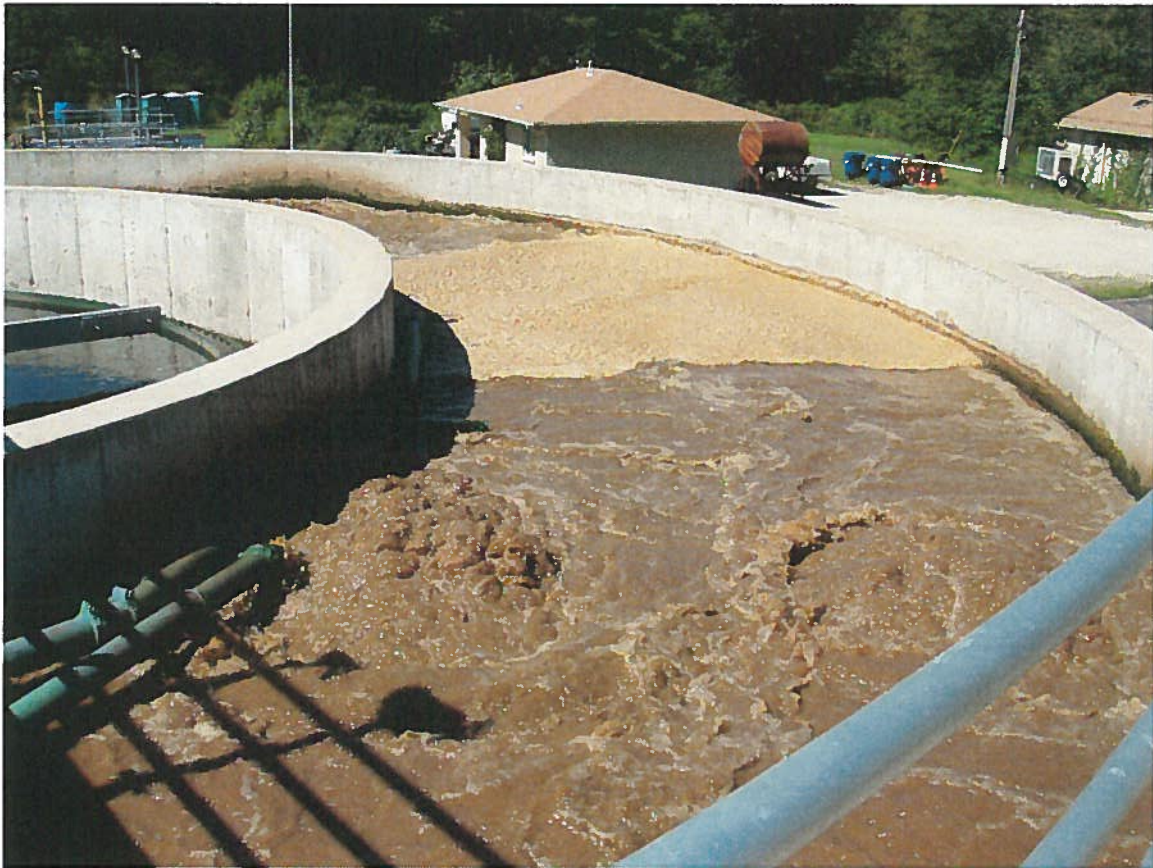
Photo no. 3 This photo was taken looking northwest from the headworks structure looking at the west aeration basin. Note the large boil type aeration pattern. A fine bubble pattern would add more air. The building at the upper center is the laboratory/office. Located at the right edge of the photo is the raw sewage pump building.

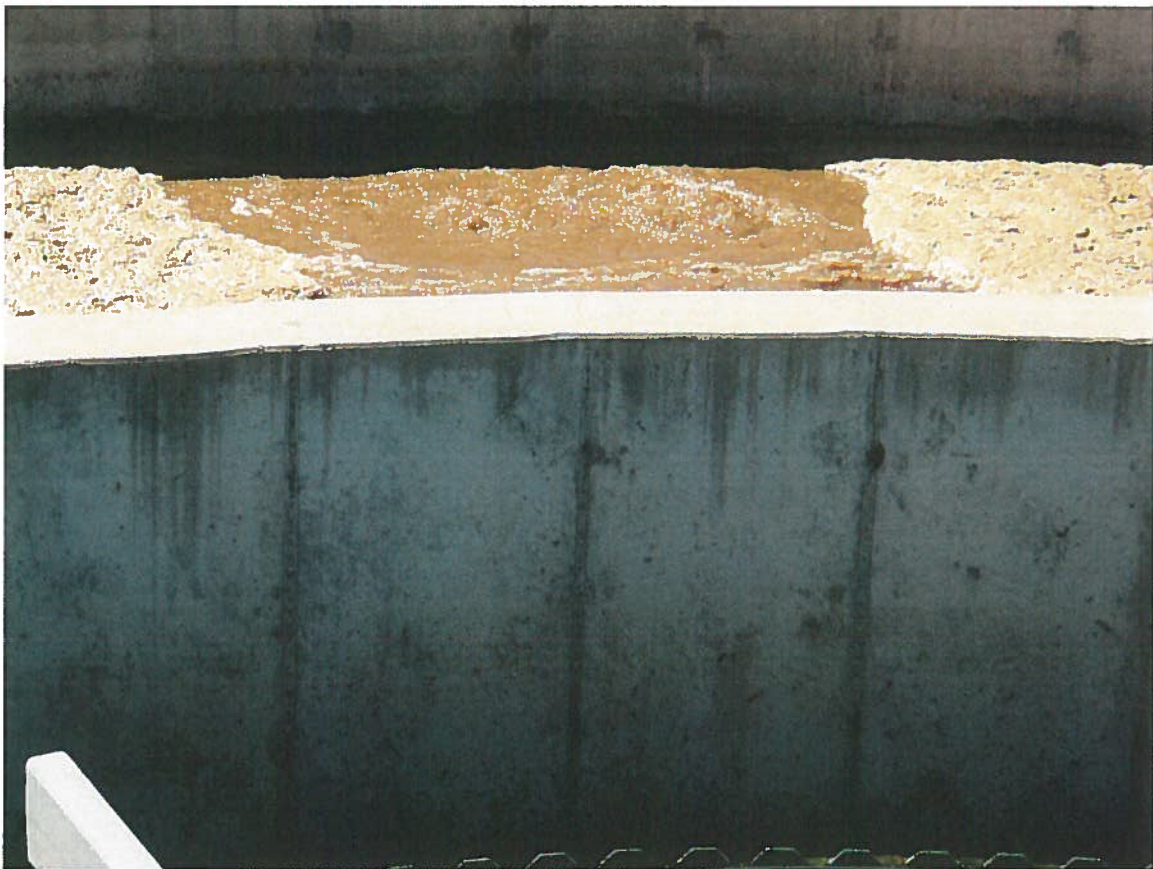
Photo no. 4 This photo was taken looking west at the west aeration basin. The photo was taken from the final clarifier bridge. The aeration bubble was large indicating coarse bubble diffusion resulting in poor oxygen transfer.

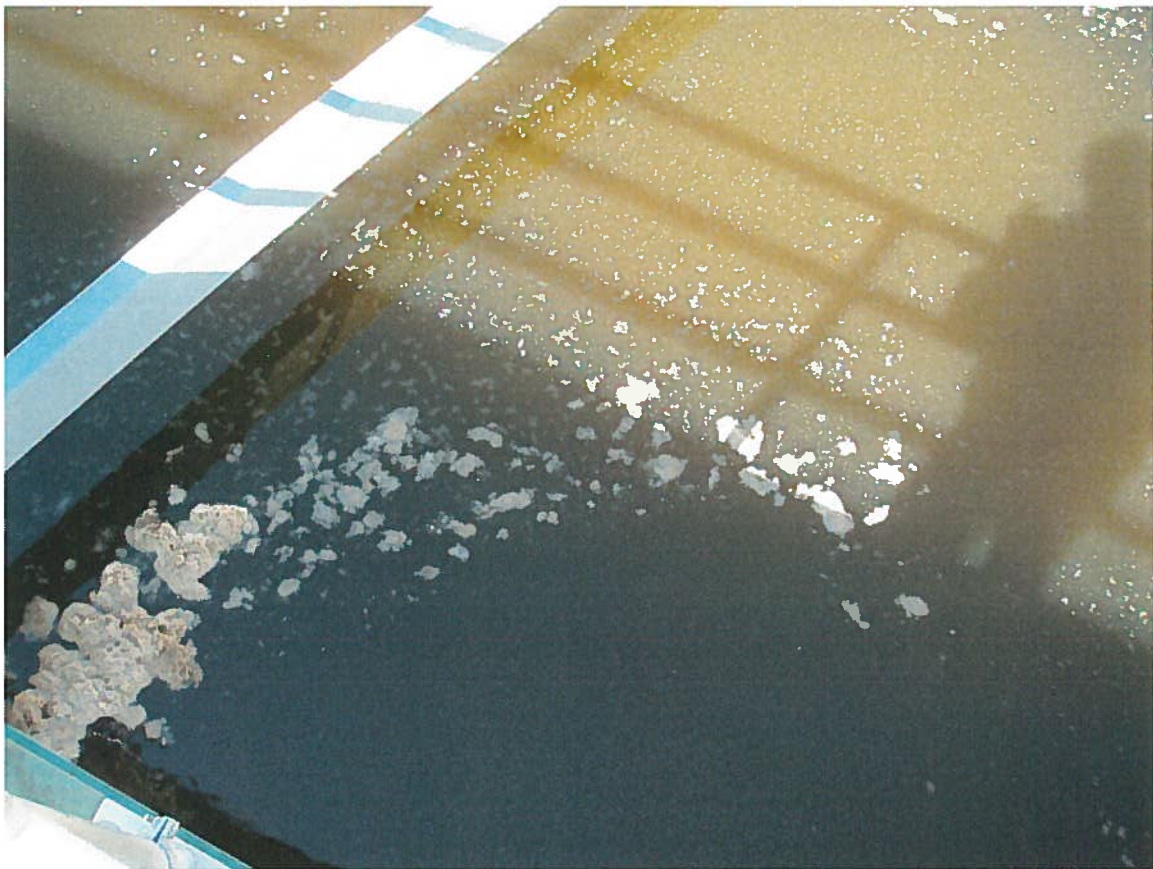
Photo no. 5 This photo was taken looking down at the surface of the final clarifier.
Floating surface scum is visible.

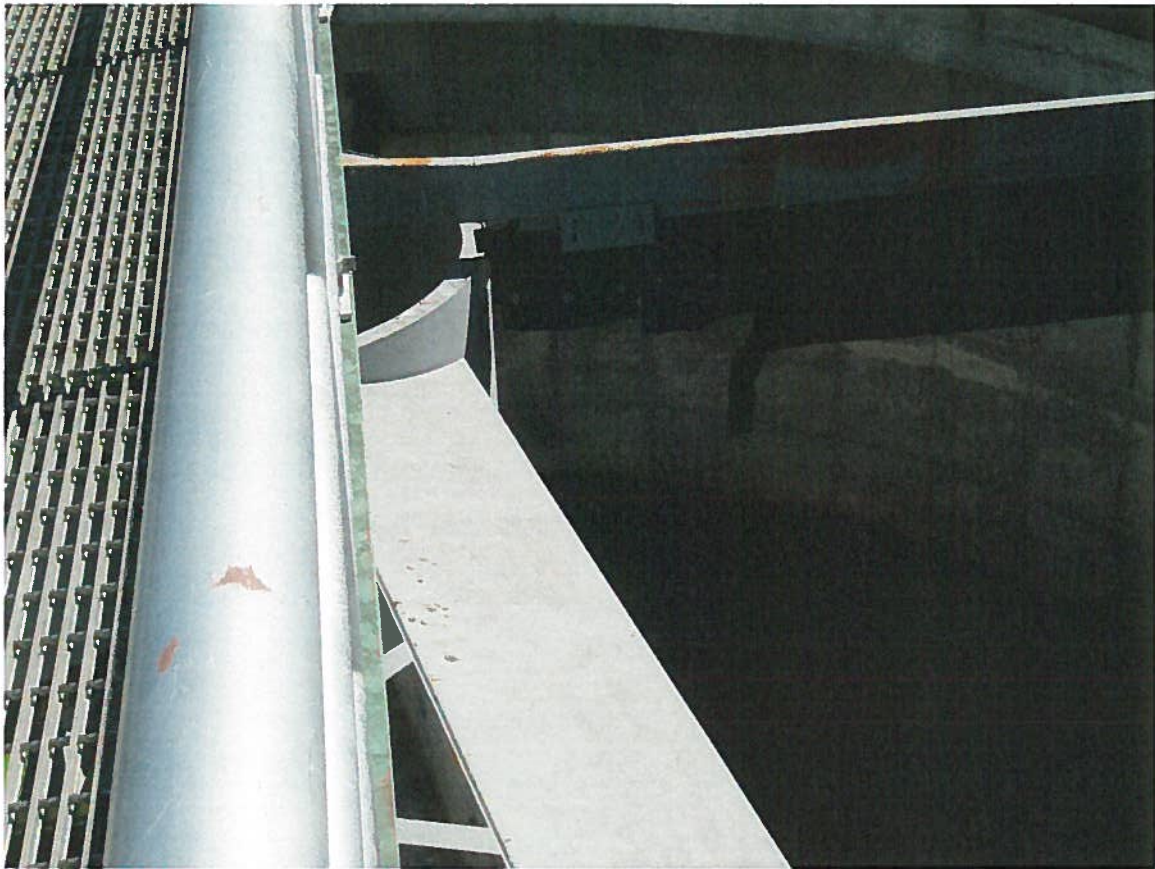
Photo no. 6 This photo was taken looking at the clarifier surface skimmer of the new clarifier not in use.

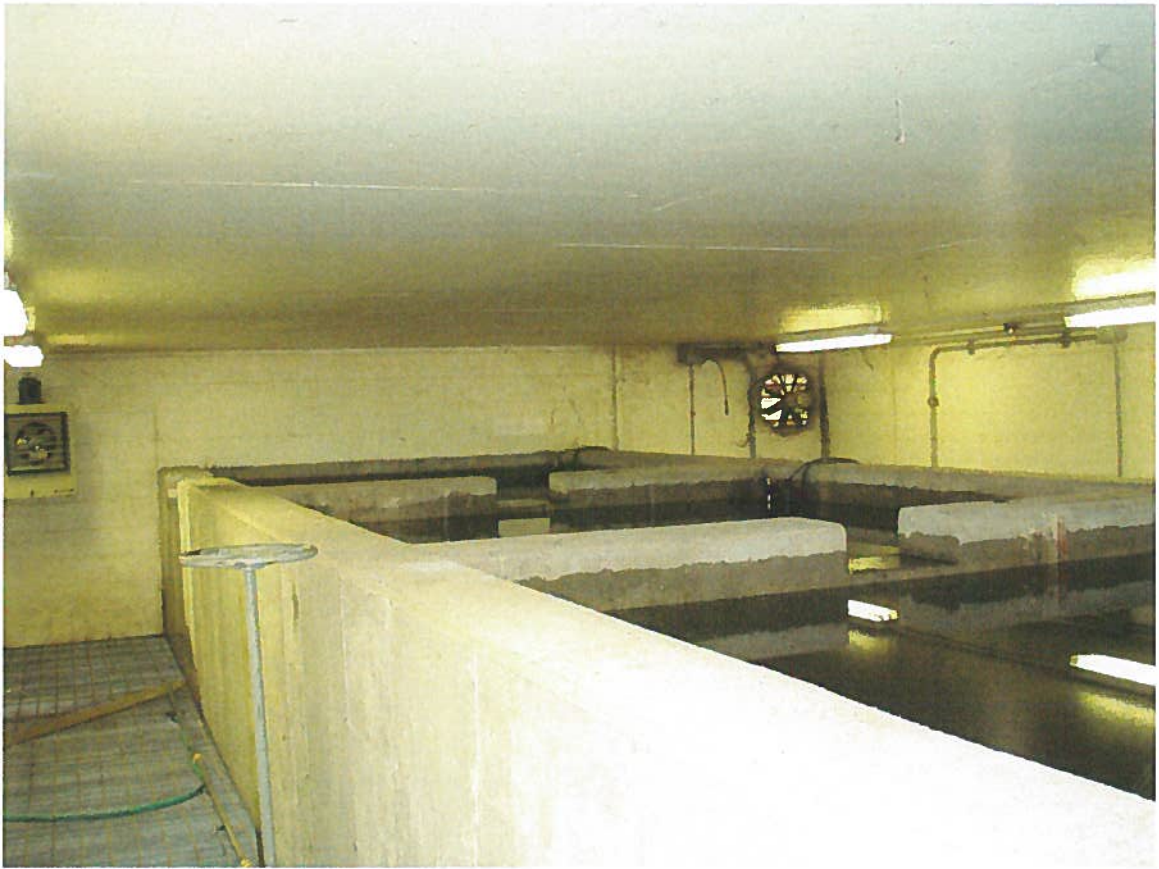
6. Because the sand filter backwash pumps had failed previously and not been repaired, the sand filters became plugged. The operator routinely diverted the clarifier effluent around the sand filters directly into the UV light channel. However, on the 2nd day of the inspection, September 11, the sand filters were being used. The sand filters failed to pass all the flow. As a result, the filters overflowed directly into the discharge channel (see Photo No. 25). As a result, this flow didn't pass through the UV light bank. This is a bypass as defined by Standard Conditions to the NPDES Permit, Part 1, Section B(5). Mr. Godley was advised of the requirement to provide a telephone report to the Southwest Regional Office of MDNR within twenty-four hours and a written follow-up within five days. This was not done. Based upon the condition of the sand filters and related equipment, any use of the sand filters would result in a bypass that would require reporting to MDNR. There were no records to establish the filters being used or any resultant bypass.

Photo no. 7 This photo was taken inside the sand filter building. Visible are three of the four sand filter basins used to remove solids before the ultraviolet light disinfection channel. The sand filters are not in use in this photo.

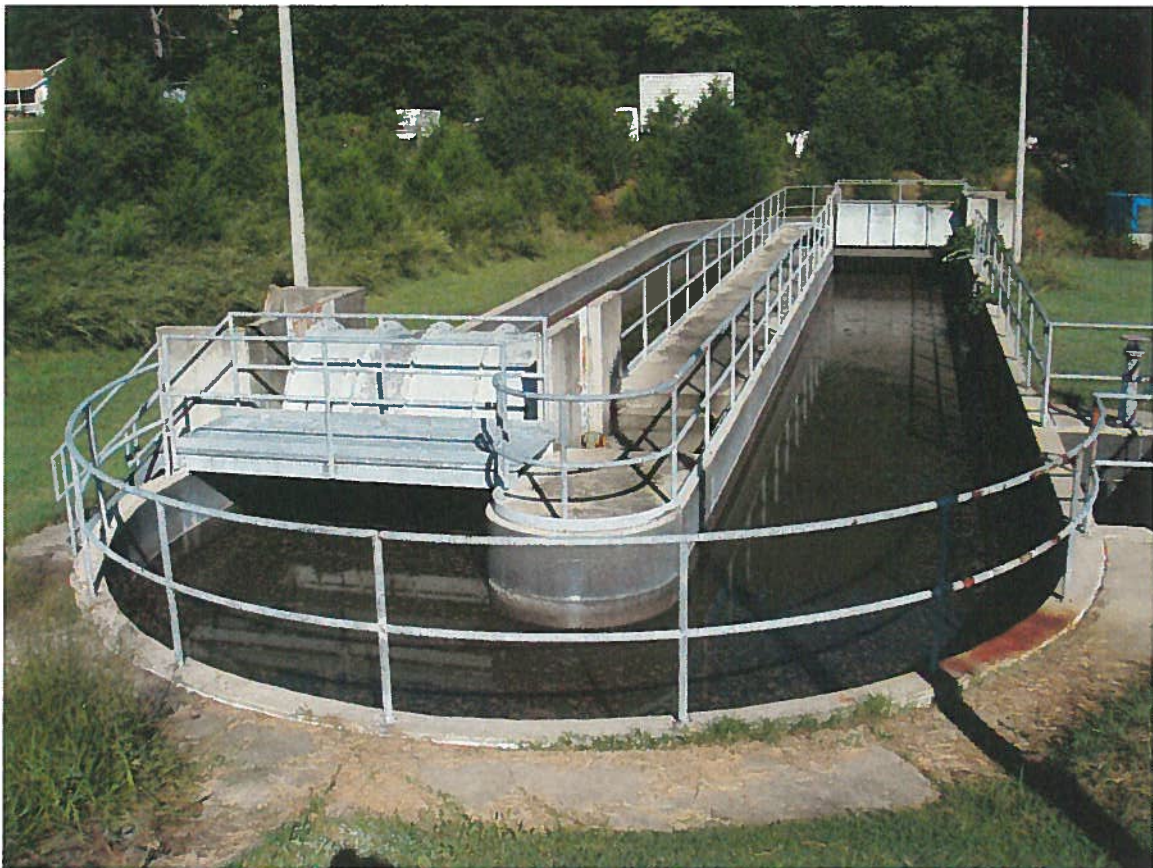
Photo no. 9 This photo looks northwest and shows the old oxidation ditch which was to be used as an aerobic digester. The design intent was to run the aerators continuously. Because of odor complaints, the rotors are not normally operated.

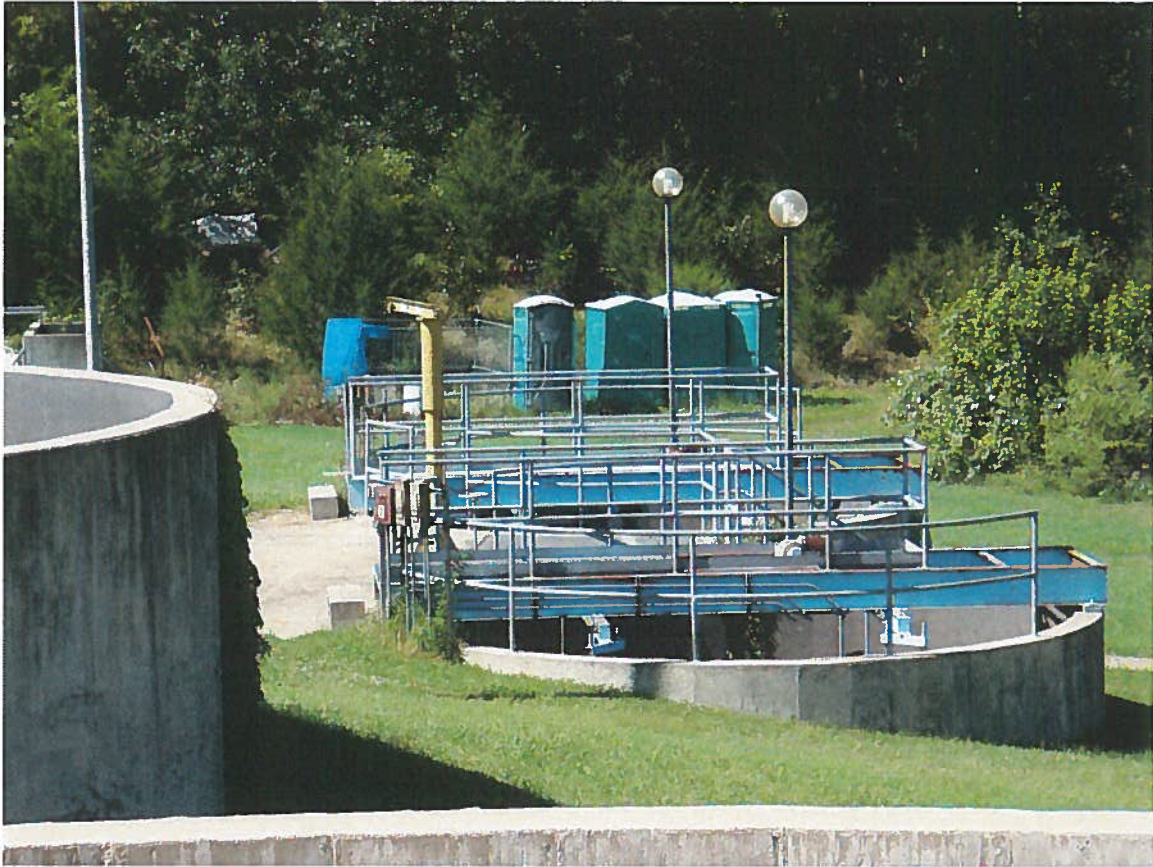
Photo no. 10 This photo was taken looking northwest from the west final clarifier access bridge. The photo shows the sludge storage tank at the left of the photo. The two final clarifier tanks associated with the old plant are shown at the center right. The plant design intent was to use these clarifiers as gravity thickeners then store the sludge in the sludge storage tank. These tanks are currently used as storage with no regard to sludge thickening.

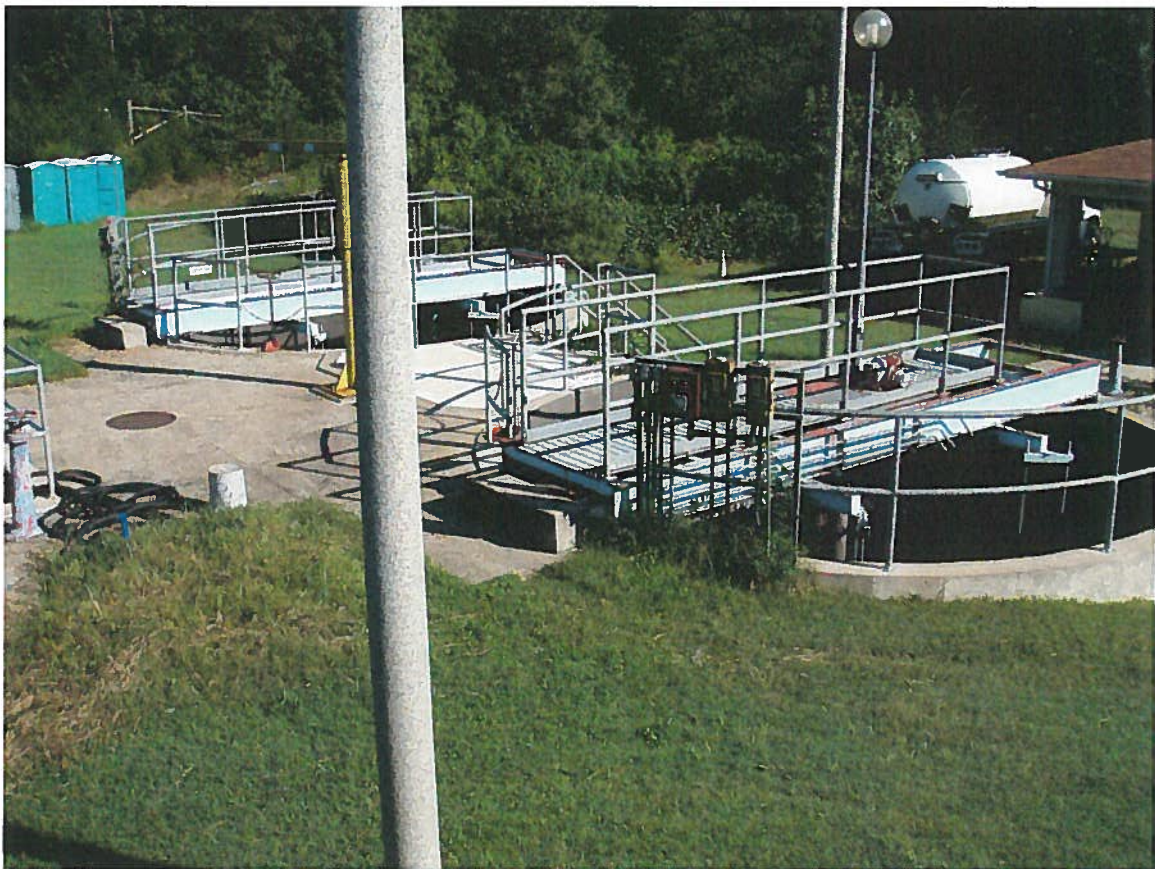
Photo no. 11 This photo was taken from the old sludge storage tank looking north. It shows the two old final clarifiers that were intended to be used as sludge thickening tanks. They are used as such with the water decanted manually using a pump. The sludge is pumped from these tanks into the liquid sludge haul truck which can be seen at the upper right.

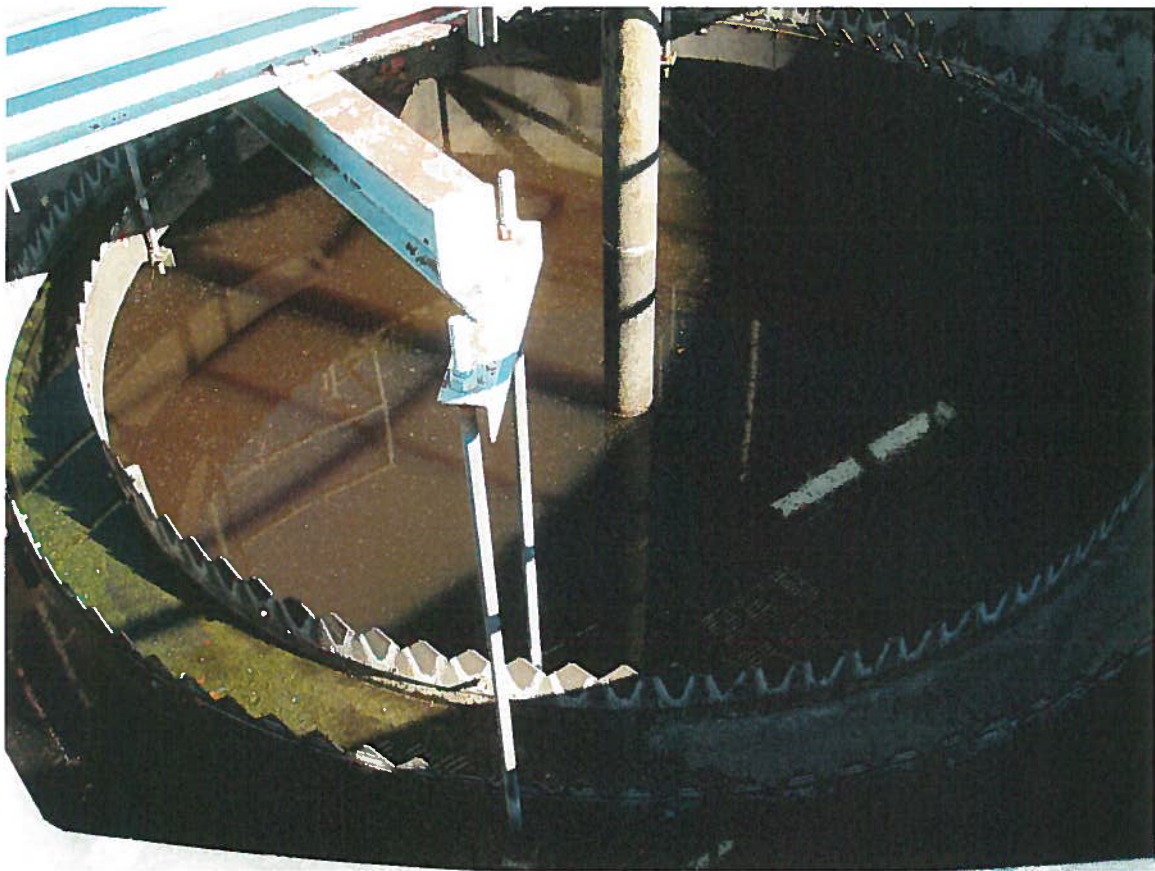
Photo no. 12 This photo was taken from the top of one of the old final clarifiers. The visual appearance of the clarifier suggests that it is not being used as a gravity sludge thickening unit but more as a storage basin.

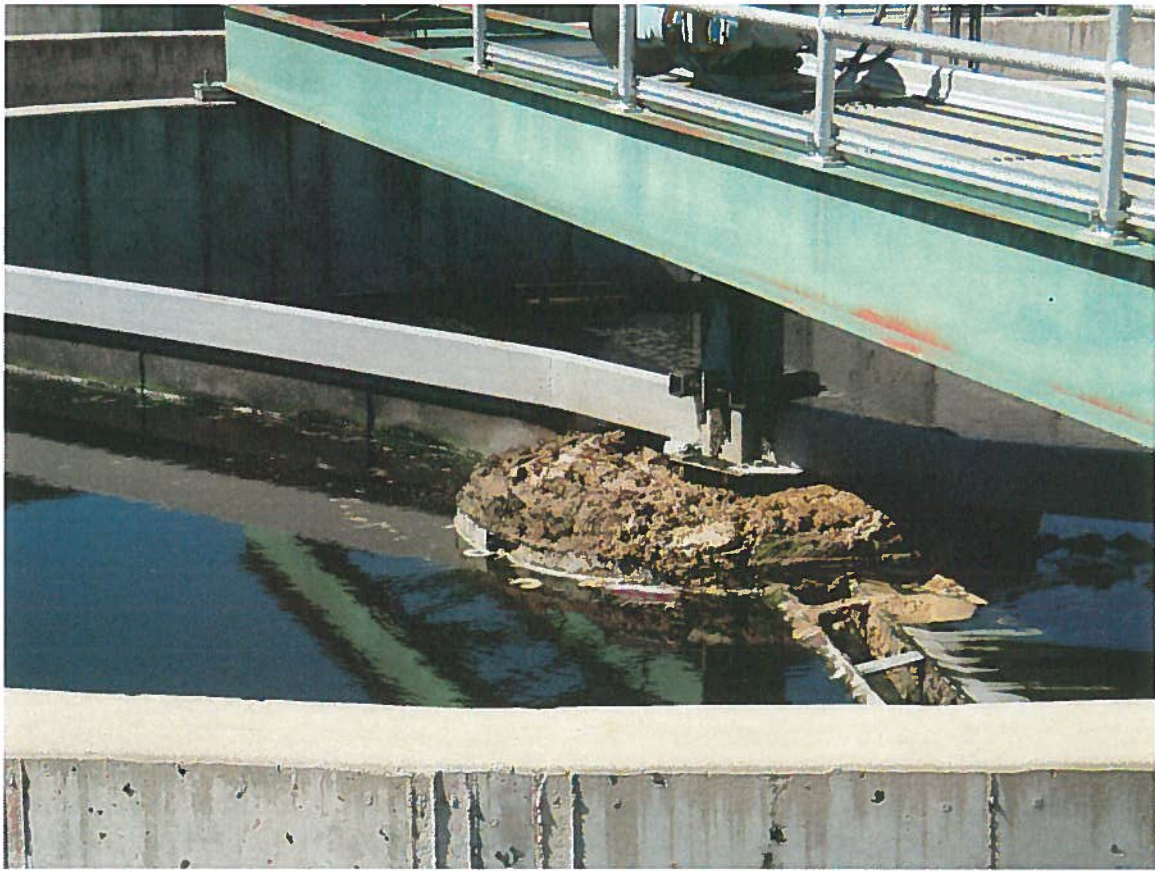
Photo no. 13 This photo was taken looking northwest from near the old final clarifier. Some water could be decanted from the clarifier surface.

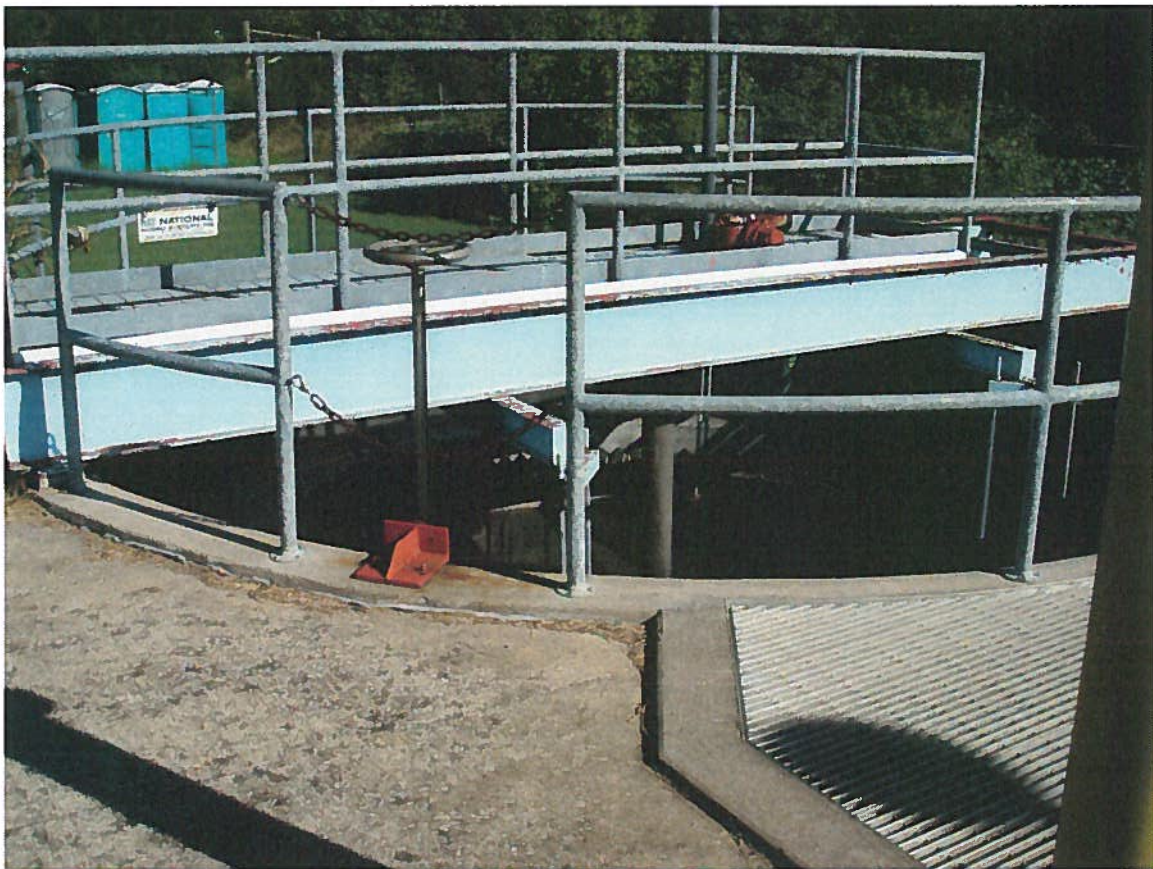
Photo no. 14 This photo was taken looking northwest at one of the old final clarifiers.

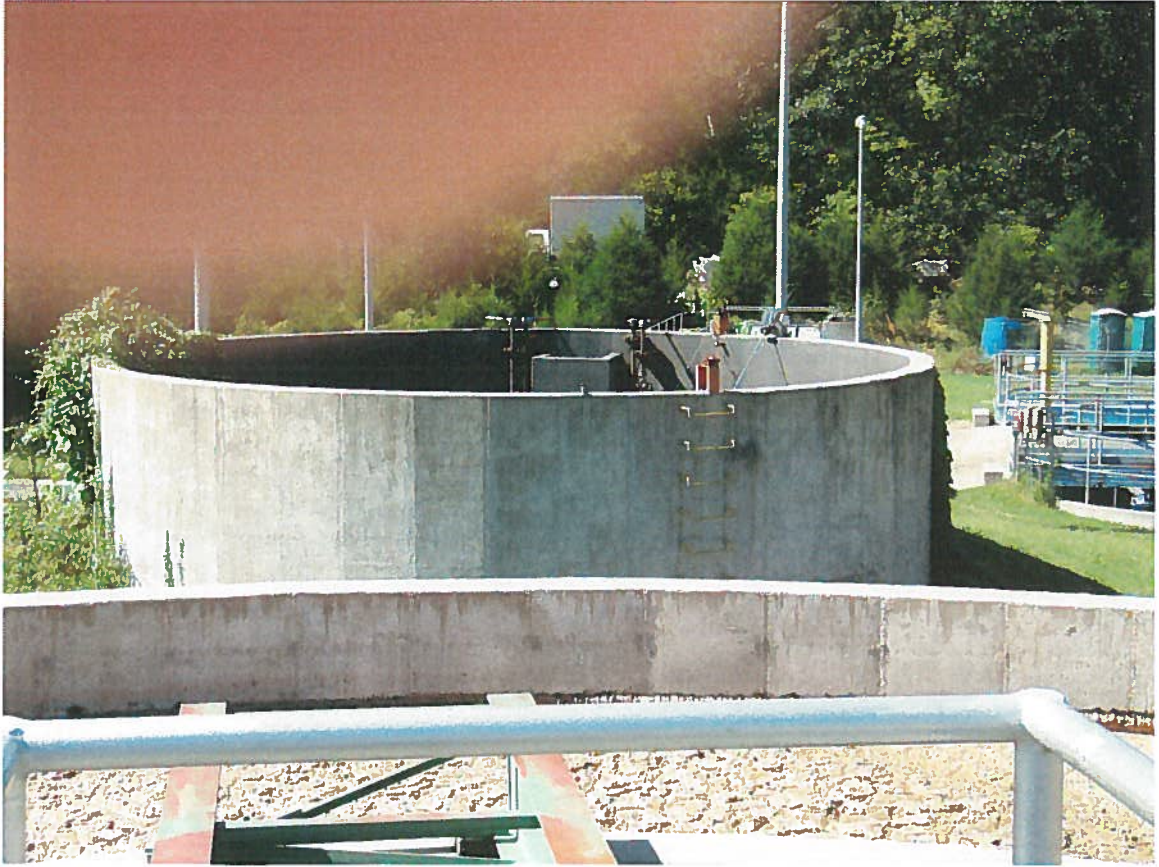
Photo no. 15 This photo was taken looking northwest from the west final clarifier access bridge. The upper center of the photo shows the sludge storage tank. This tank has not been used since the new plant was constructed.

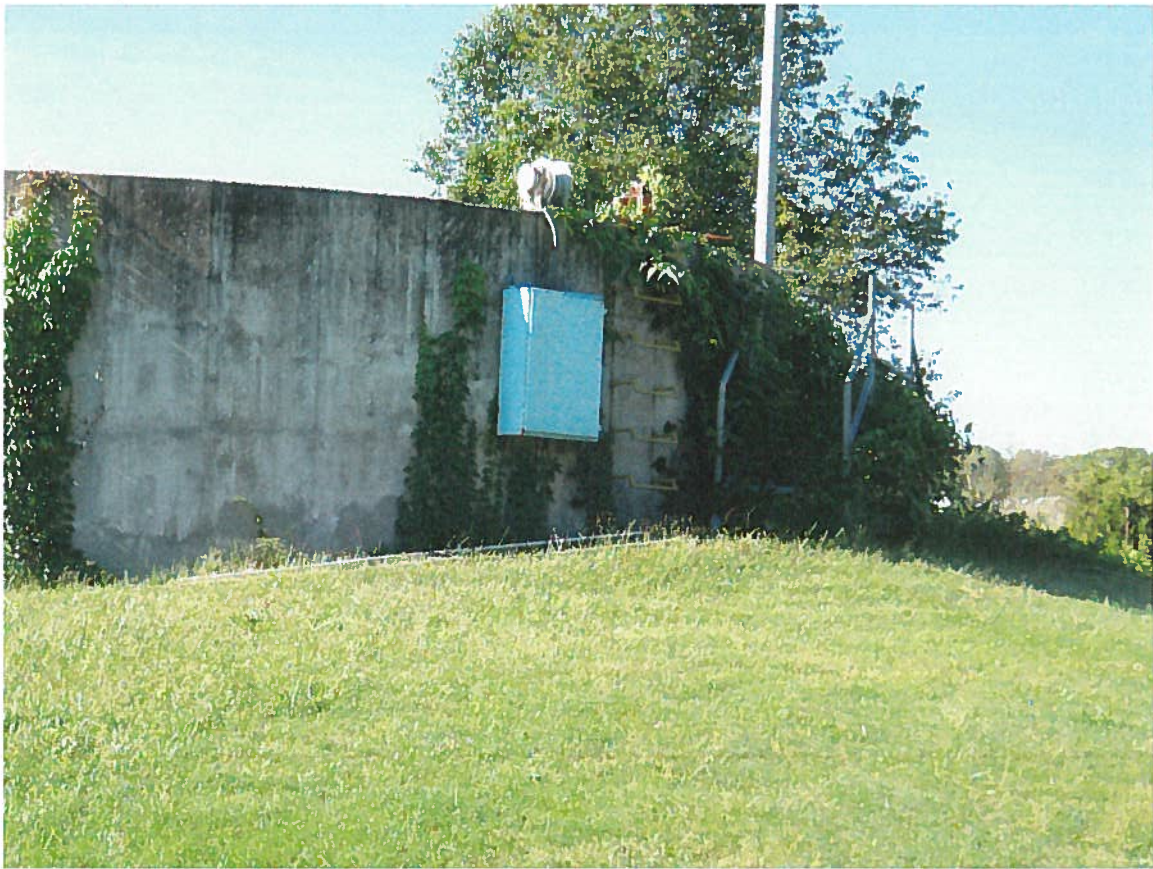
Photo no. 16 This photo was taken from near the new treatment tanks looking west at the old sludge holding basin. The access stairs have grown up in vines that limit access to the unit. Access is not an operator concern since he doesn't use the tank for sludge storage.
